EXERCISE DESERT ROCK LAS VEGAS NV  
EXERCISE DESERT ROCK VII AND VIII. ANNEX L.(U)  
1957

ANNEX L  
TO FINAL REPORT  
EXERCISE DESERT ROCK  
VII and VIII

Damage Comparison - Predicted vs Actual - Shot "PRISCILLA"..... Tab E

Pre and Post Shot Photos - Shot "PRISCILIA" ..... Tab F

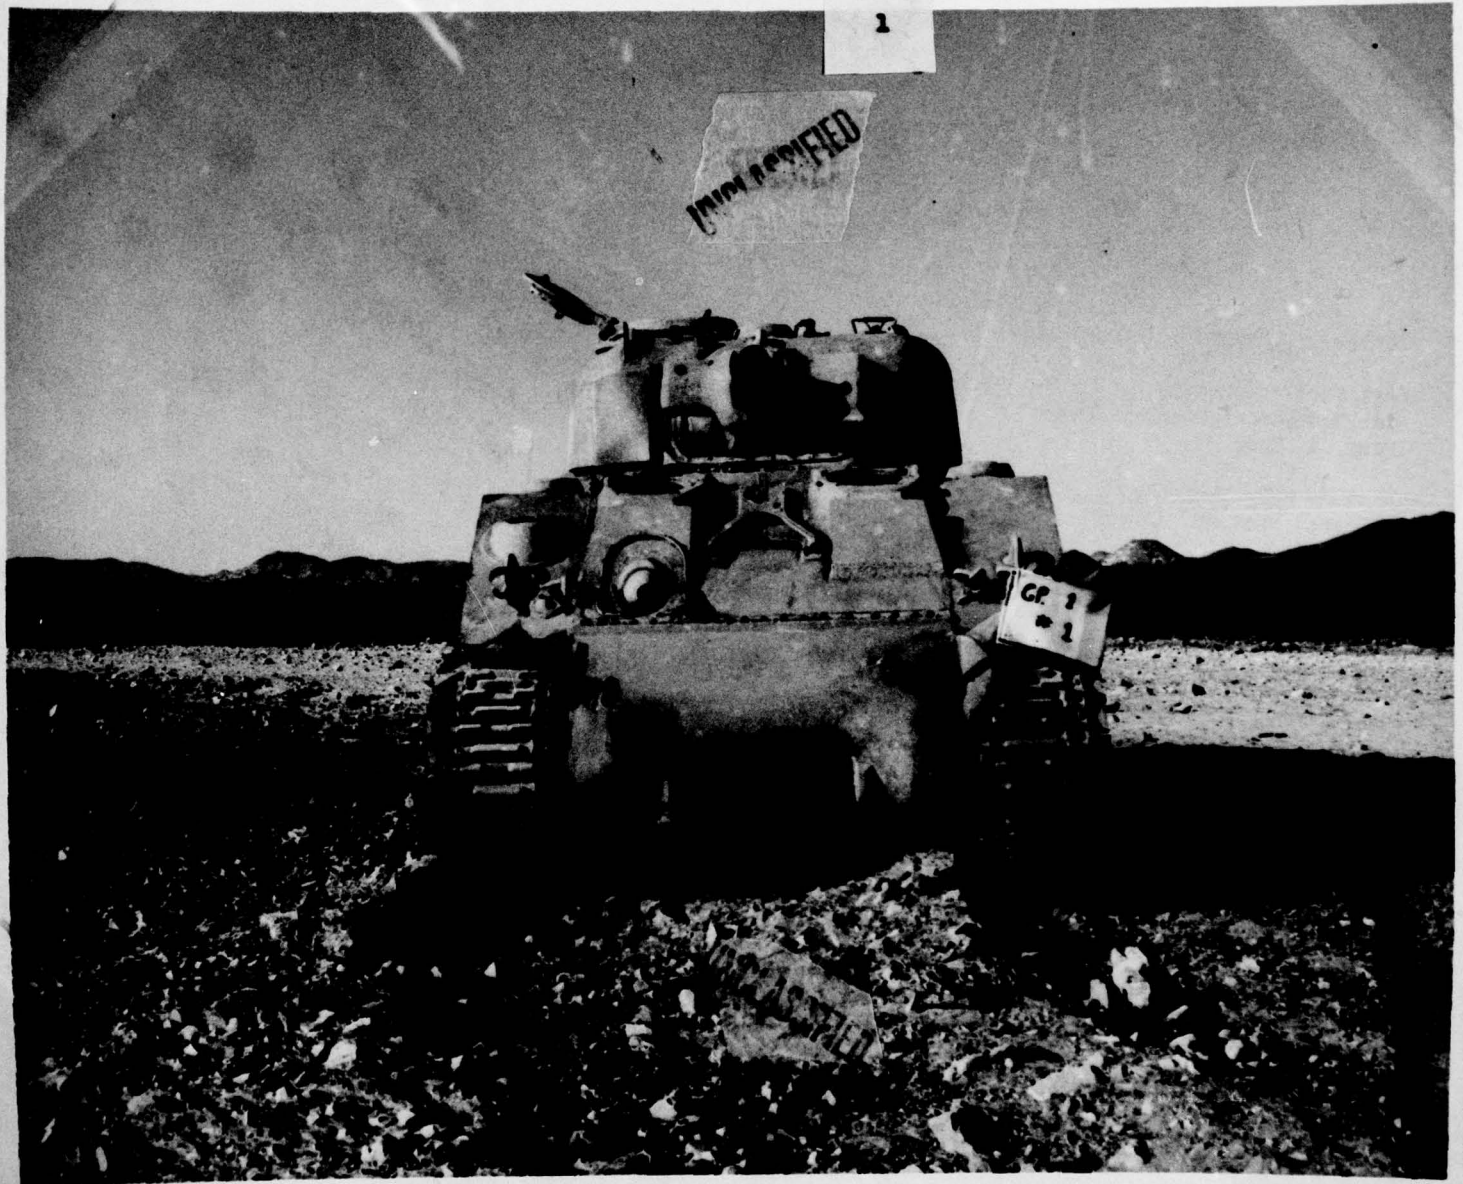
PHOTO REF. NR.	ITEM	DISTANCE From GZ (Yards)	ORIENTATION & PROTECTION	DAMAGE CLASSIFICATION		DESCRIPTION OF ACTUAL DAMAGES
				PREDICTED	ACTUAL	
1	Tank, M-4	450	Head on, surface	Severe	Moderate	Tube blown off turret; tank displaced about 40 feet; tank appeared intact otherwise.
2	Gun, 57mm	450	Side on, surface	Severe	Severe	Wheels and operating handles blown off; one spade bent out of position; displaced 45 yards.
3	Gun, 90mm	450	Head on, surface	Severe	Severe	Destroyed; one wheel missing - remaining torn apart; outrigger leg blown off and the other distorted; displaced 100 yards; tube and part of mechanism displaced 50 yards further away from carriage.
4	Tank, M-24	450	Side on, surface	Severe	Severe	Track blown off and found in 4 parts within a 50 yard radius; tank overturned; bogie wheel bent out of line; drive sprocket bent out of line; tank turret blown off and displaced 100 yards from tank; gun tube torn loose from turret and laying 20 yards away; tank displaced 15 yards.
